# ERYLDENE CONSERVATION MANAGEMENT PLAN

17 McIntosh Street, Gordon

May 2023

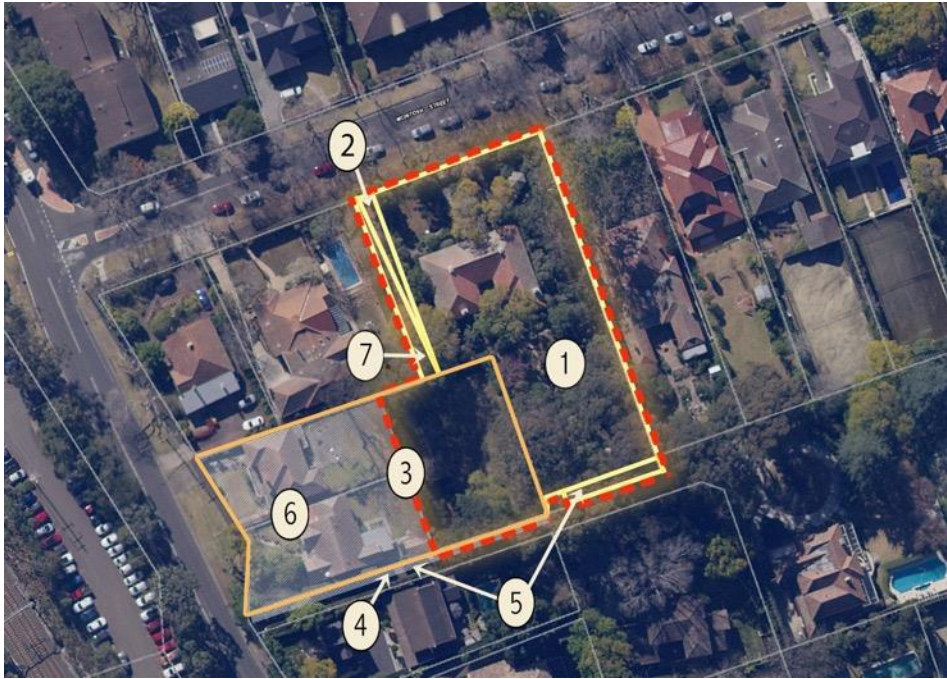
Figure 7.1. The evolution of Eryldene. The red outline shows the current boundary.

1. 1913 (June): EGW's original purchase of Lot 3, Section 3 in D3267.
2. 1913 (December): a triangle 12ft wide at the McIntosh Street frontage was added, tapering to a point near where the steps to the tennis court are today. This placed the house more evenly on the block when viewed from McIntosh Street. The house, temple, and formal paths were completed by April 1914. The paths had a pebbled surface, which was replaced by flagstones by 1921.

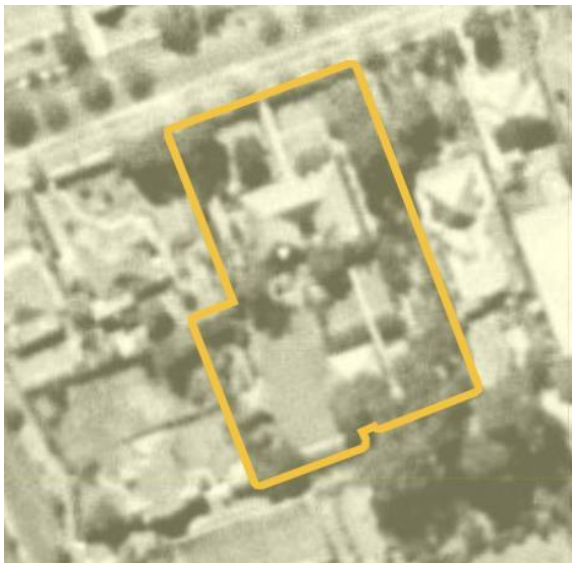
**Figure 7.3a.** 1943. The garden study is screened from the back lawn by planting and the angophora extends over the rear of the garden study. The jacaranda near the eastern loggia and the two on the embankment are well-established. The garden on the eastern side of the house is not overgrown: the path can be seen clearly.

The series of aerial photographs taken of the area between 1943 and 2021 provide a useful overview of the growth and large-scale changes to the garden and spaces over this time, particularly in providing information about changes in the parts of the garden not included in the historic photographs (see Figure 7.3). The following images are sourced from the [Land and Property Information \(LPI\) online records of Historic Imagery](#).<sup>15</sup> Additional photographs are included in the set, although some are poor quality and of limited use.

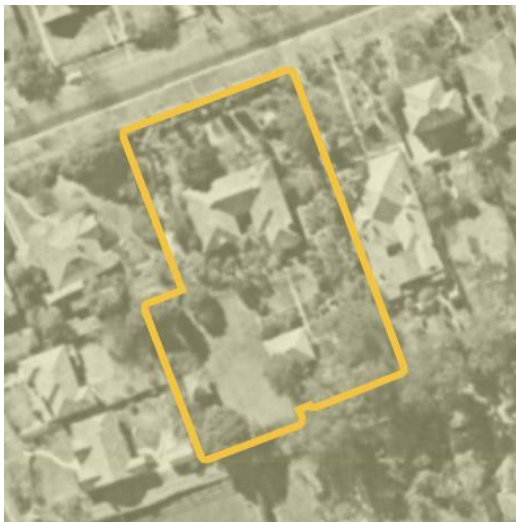
**Figure 7.3b.** 1965: Areas of shrubs have been added to the rear of the house, the embankment area, and the eastern boundary near the back lawn. Shaped plantings have been added and some of the vegetation to the south of the garden study appears to have been cleared.

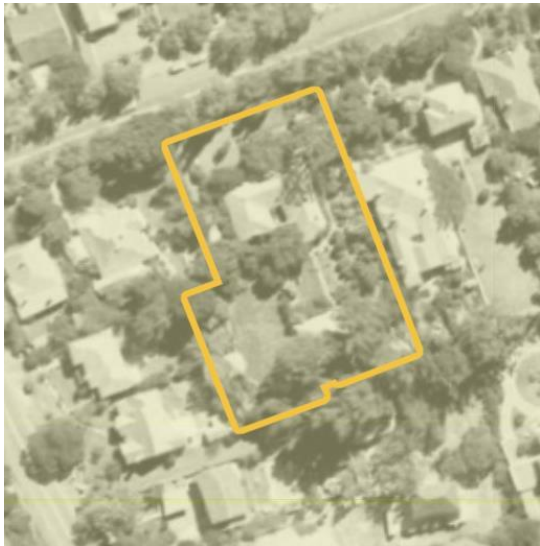
**Figure 7.3d.** 1978: Trees along the eastern boundary have been removed or trimmed. The eastern side path is again visible and most of the plants in this area are modest in size. The edges of the tennis court are not as clearly marked. The olive tree in the front garden has been heavily pruned.

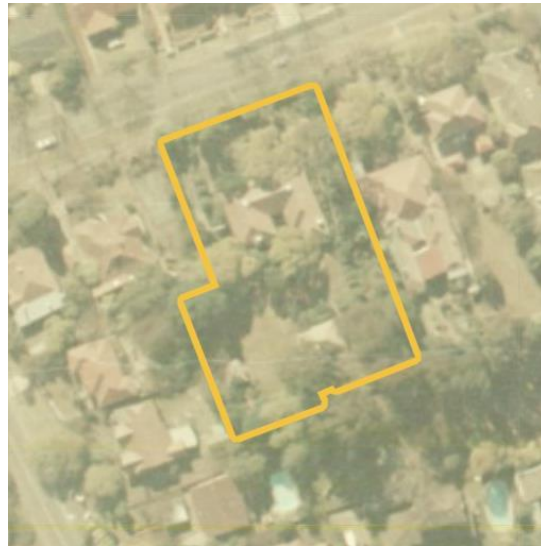
**Figure 7.3e.** 1986: Trees are re-establishing. The angophora in the back garden extends over almost half of the garden study.

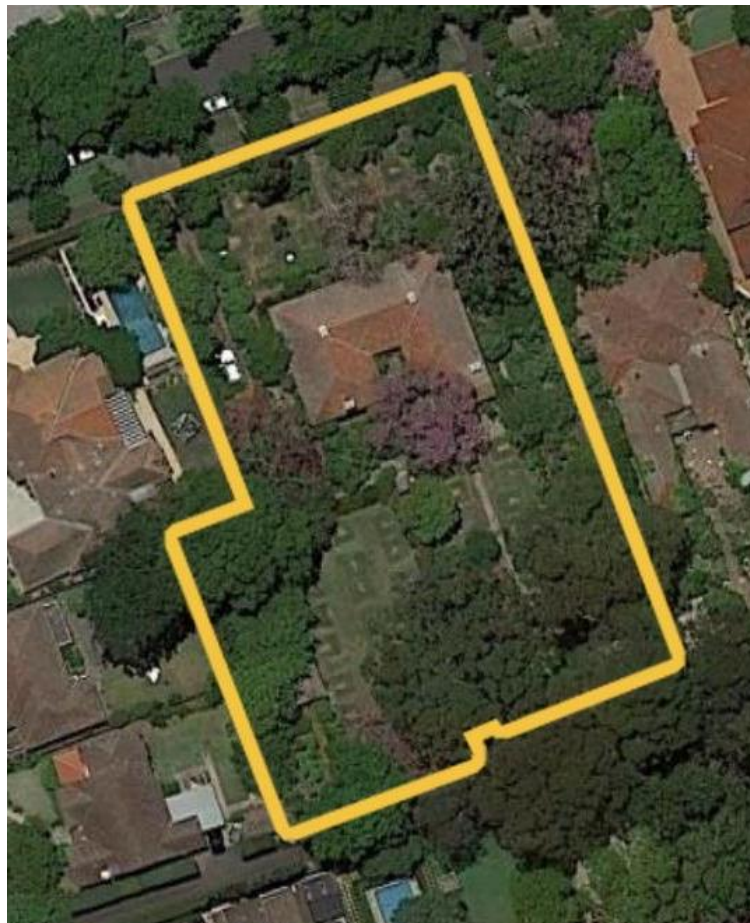
**Figure 7.3f.** 2019 – Taken on the last Monday in November 2019 in the period between the Christmas Fair and the major storm of that year. The pattern of wear on the grass of the tennis court from the stalls is clearly visible. The roof of the garden study is entirely beneath the canopy of the angophora. (Google Maps 2019).

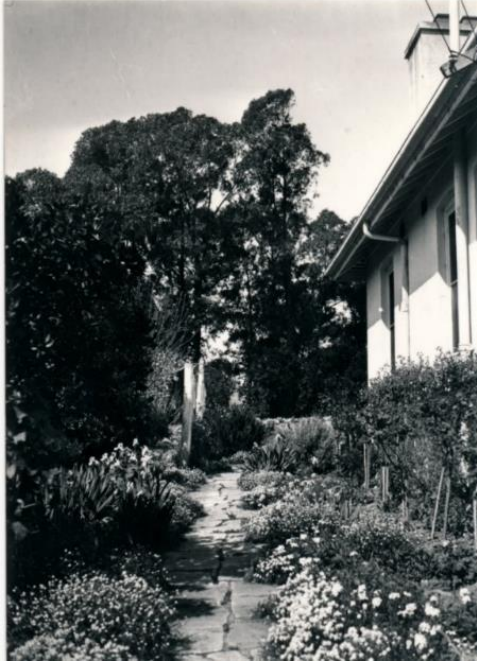
**Figure 7.5a.** Looking through the eastern garden toward the trees at the rear of the property in 1922. Note sweet alyssum and backdrop 'hedge' that Ian Waterhouse remembered attracted blue wrens. (Harold Cazneaux, copy in Eryldene collection, Image ERY1922006.jpg).

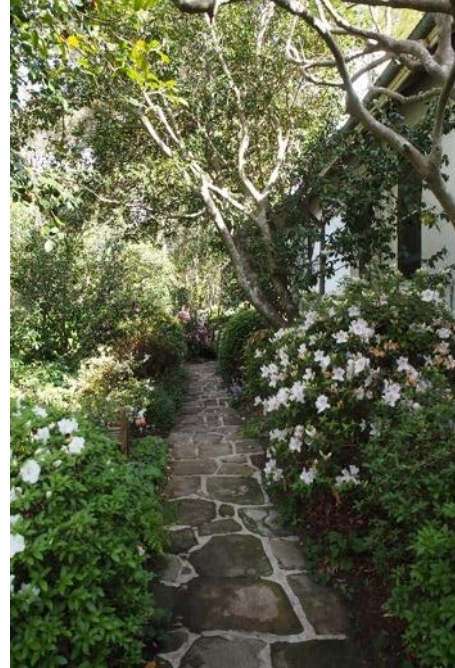
**Figure 7.5b.** Looking through the eastern garden towards the trees at the rear of the property in September 2019. Note infill between pavers, growth of shrubs, and particularly the camellias now well above the gutter line.

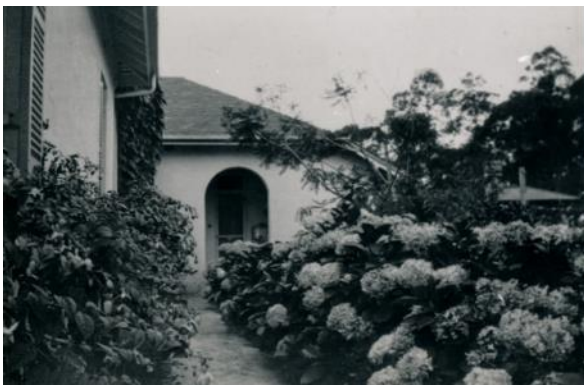
**Figure 7.6a.** The path leading from the garage across the rear of the house to the rear porch and entrance to the kitchen. This 1922 Cazneaux photograph shows the embankment planted with hydrangeas and the jacaranda approximately 2m in height. (Harold Cazneaux, copy in Eryldene collection, Image ERY1923003.jpg).

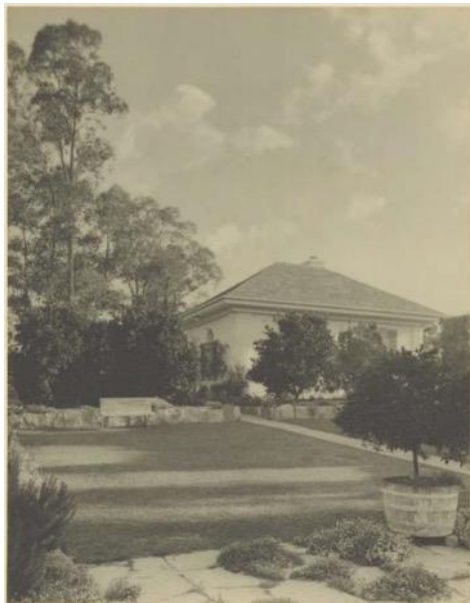
**Figure 7.8a.** The garden study from the rear of the house in 1923. The angophora behind the tea house is not visible, suggesting that it had been coppiced by this time. (Cazneaux, Exterior view of Eryldene house, garden path. Gordon, New South Wales, ca.1930 [picture] [sic]. Copy in National Library of Australia, accessed online at <https://nla.gov.au:443/tarkine-beta/nla.obj-147890266> (27 June 2020). Note: the attributed date of 1930 is not accurate. This image was published in the 1923 article 'Eryldene, Gordon, New South Wales. The Residence of Mr & Mrs E.G. Waterhouse. House and Garden designed by Wilson, Neave and Berry' in *The Home* magazine, June 1 1923, p.28.

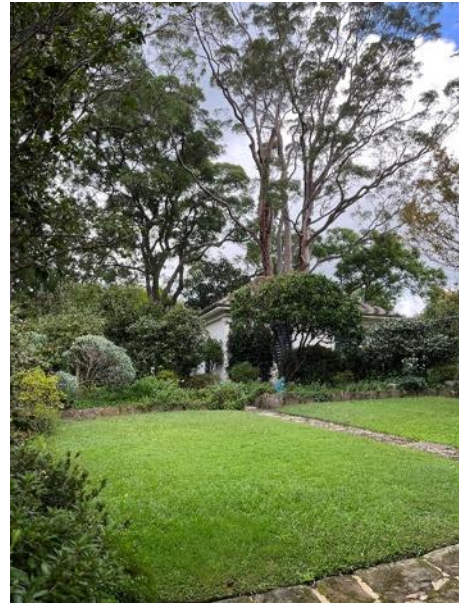
**Figure 7.8b.** The same view a century later in March 2023. Note the orange tree now hides the roof of the garden study and the scale of the angophora dwarfs the garden study. (Sheridan Burke).

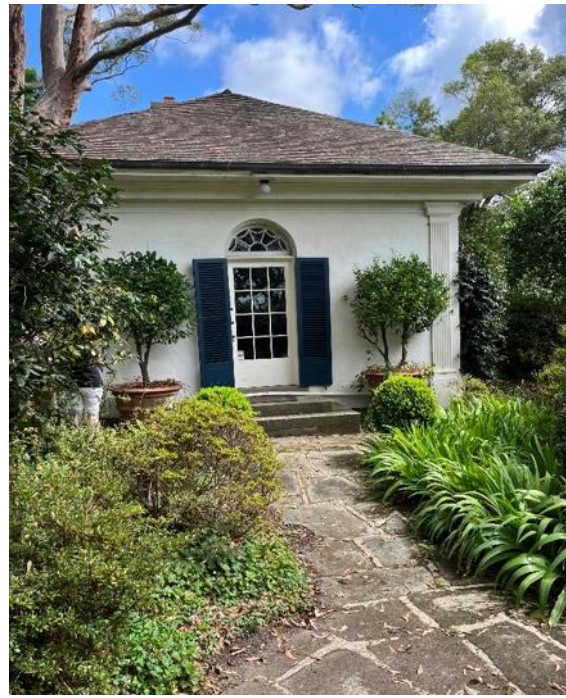
**Figure 7.8d.** Eastern elevation in 2023. Note cumquats have replaced oleanders in the tubs beside the door. (Sheridan Burke).

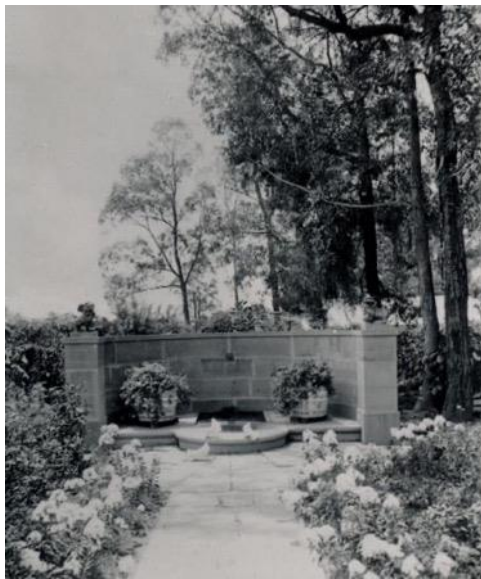
**Figure 7.8e.** The walled fountain in 1923 soon after its completion. The medallion at the centre of the rear wall aligns through the garden study with a matching medallion on the rear wall of the tea house. (Cazneaux, copy in Eryldene collection, Image ERY1923014.jpg).

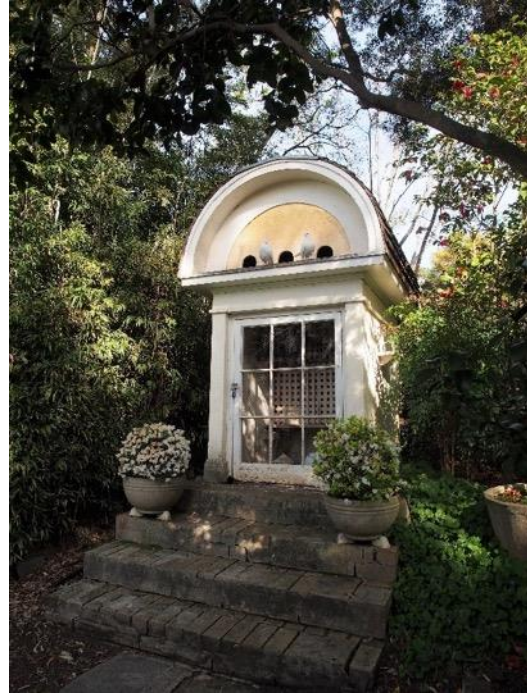
**Figure 7.8h.** The pigeon house in 2019 after conservation work, including a new timber shingle roof and re-gilding of the tympanum.

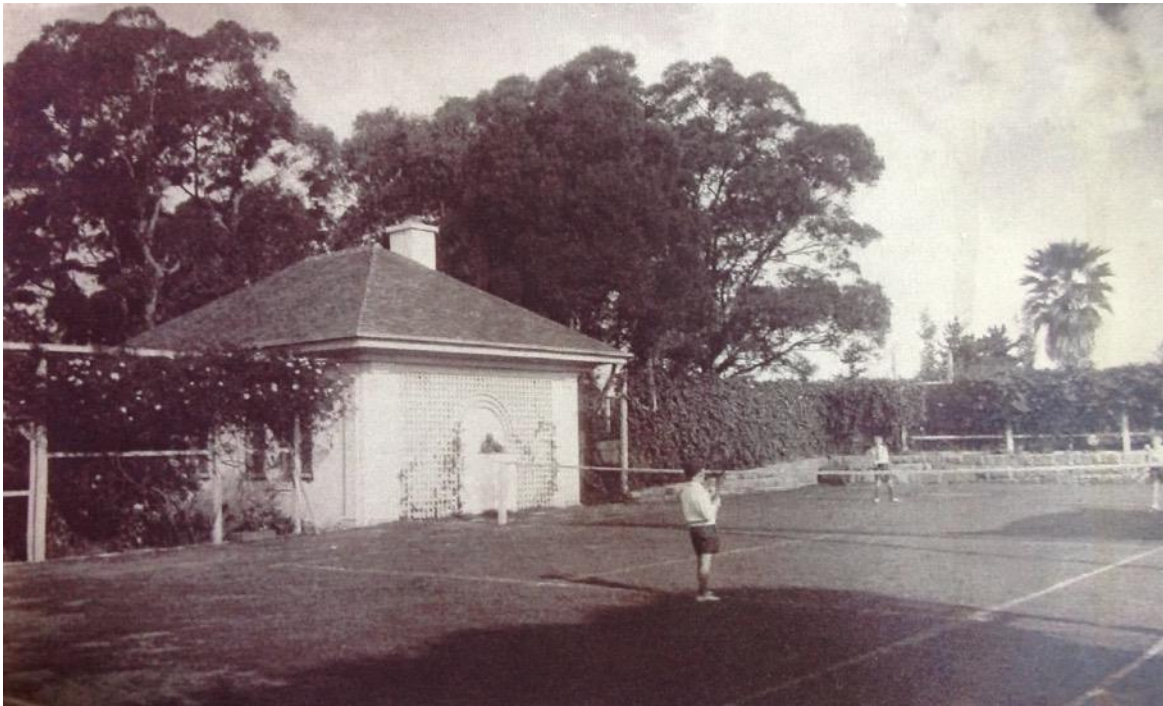
**Figure 7.8i.** The Waterhouse boys playing on the tennis court ca.1920s. Note the immature growth of the virginia creeper on the garden study wall and the original timber frame and square gate to the tennis court boundary (where the moon gate is now) suggests a date between 1921 and the 1930s. The dark foliage behind the garden study may be re-growth of the coppiced angophora, which has now grown to imposing height and canopy (see next page). (Cazneaux, copy in Eryldene Collection). This image was used to illustrate the article 'Tennis courts for the Private House may be Pleasantly Handled to Serve a Decorative Purpose' in *The Home* magazine (2 January 1928).
